Corrosion evaluation of glass fiber reinforced plastic (gfrp) Tanks & pressure vessels using acoustic emission technology

Mathias André¹, Denis Siguret², Anthony Foulon³, Salim Benmedakhene^{1*}, Pierre Mékarbané², Abdelouahed Laksimi³, Christian Lemaitre⁴, Jérôme Favergeon³

¹ Technip: Parc Technologique des Rives de l'Oise, COMPIEGNE Cedex, France.

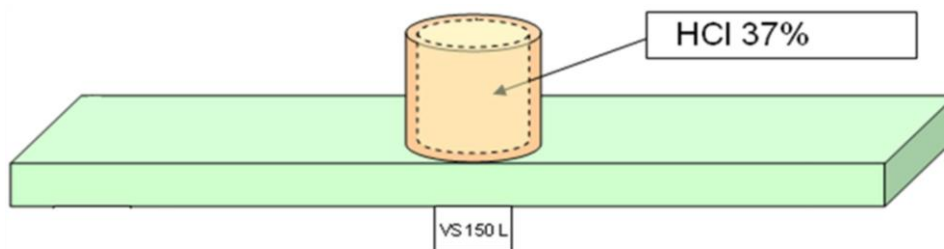
Figure 1. Experimental setup of the corrosion tests monitored by acoustic emission

Various studies have shown that the corrosion of composites could be detected by this NDT method on composite specimens in tensile, flexural and fracture toughness test, with chemical attack [1]. However, all these studies were done with a combination of corrosion attack and mechanical stress. Experiments carried out in laboratory are corrosion tests of composite by different aggressive environments (hydrochloric acid, sulphuric acid, sodium hypochlorite, hydrofluoric acid) without mechanical stress. Cylindrical cell shown in figure 1 was designed to hold acid. It is made in Polytetrafluoroethylen (PTFE).

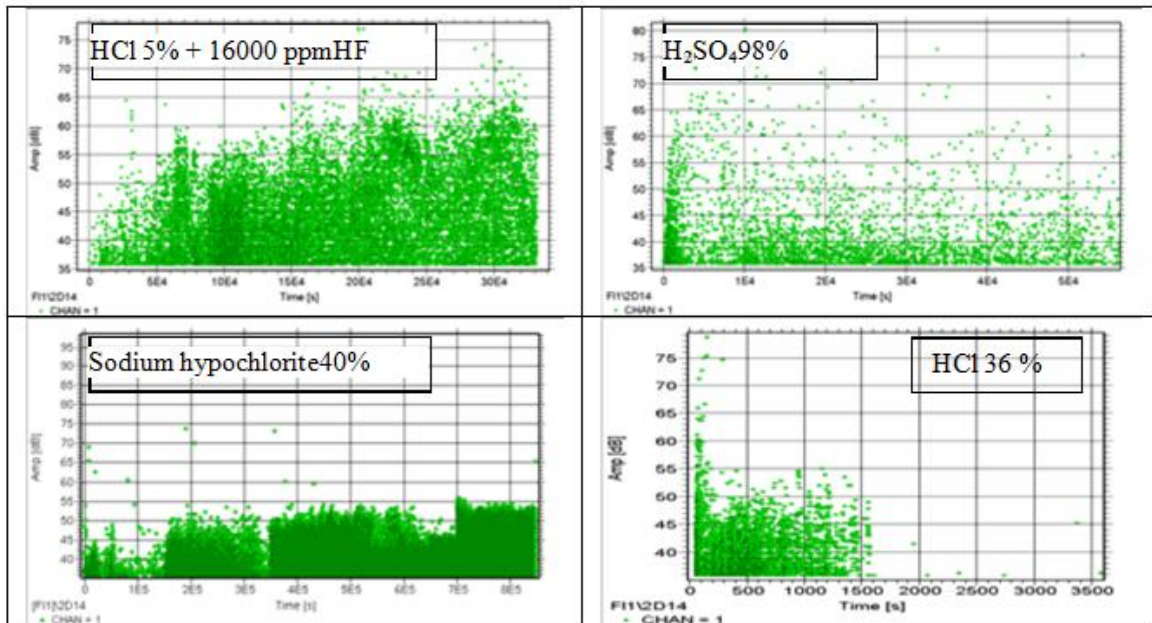
We see on the figure 2 that the different environments will create different acoustic emission activity.

Figure 2. Different acoustic emission activity due to different aggressive environments

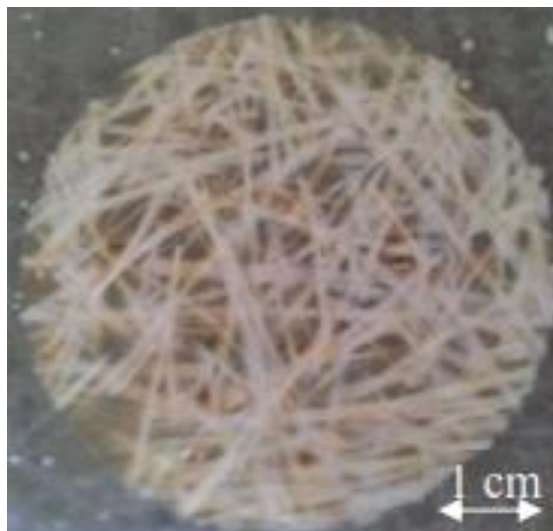
Figure 3. Picture of consequences of the corrosion on GFRP

Further investigations have been made on the corrosion of composite by hydrochloric acid. Mineral acid like hydrochloric acid is known to react with the glass fiber. The corrosion of glass fibers in mineral acid solution is less known but very important. Indeed, this corrosion is thought to be responsible of GRP failure (Fig. 3). We have shown in a previous work [2] that the variation of cumulative events with time is proportional to the microstructure. Thanks to the progress of signal acquisition and treatment technology, it is now possible to save more information from recorded signals. Thus, it is possible to determine the specific acoustic signatures of observed phenomena. Clustering of the different hit is done by using k-mean algorithmic (Fig. 4). Three different clusters have been found [3]. Now, these different clusters have to be related to the observed phenomena.

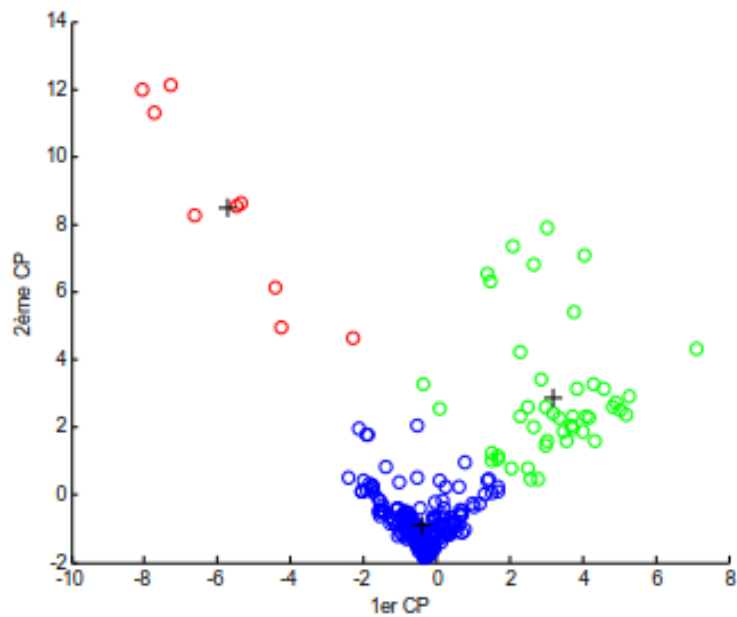
Figure 4. Result of k-mean algorithm on hits in the principal component vector space

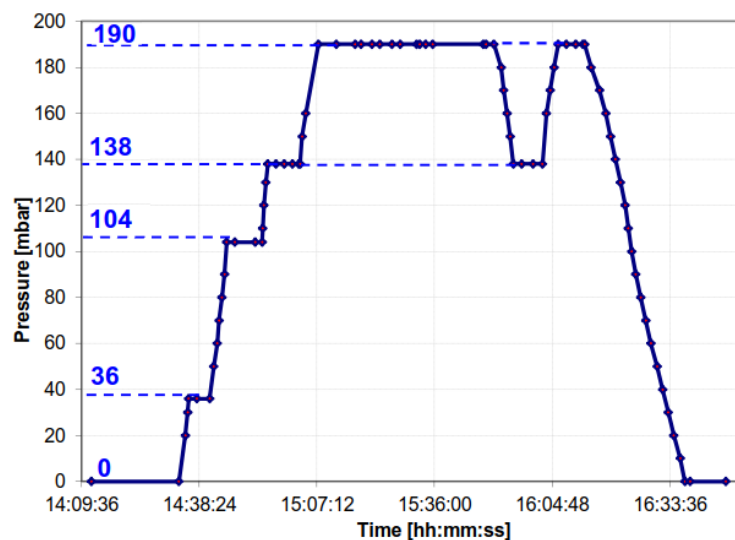
For the passive monitoring, the bromine level was held at the in service level (70%) for 2 hours. For the AE proof test, the bromine was replaced with water (for safety reasons). Due to density difference, the water was pressurised up to a P_{max} , pressure equal to 110% of the maximum pressure applied in service. The maximum pressure applied in service is equivalent to the in-service bromine liquid level. Figure 5 shows the loading sequence. The initial hold period (0 mbar) and the hold period at P_{max} (190 mbar) were at least for 30 minutes. The intermediate hold periods were at least for 4 minutes. At the end of the sequence, an unloading followed by a reloading were applied in order to verify the Felicity effect.

Figure 5. Loading sequence of the AE proof test on GFRP tank

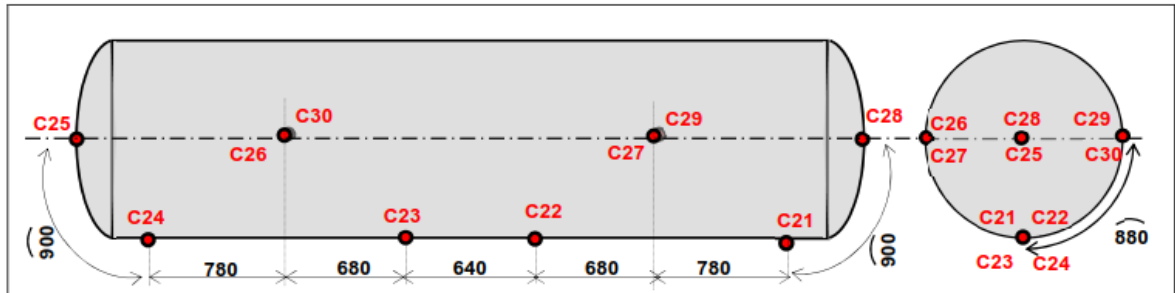
Figure 6 and figure7 show, respectively, the sensor layout on the tank for the passive monitoring and for the proof test. For the passive monitoring, the sensor layout is composed of 10 sensors and aims at covering the portion of the tank in contact with the liquid. For the proof test, the sensor layout is composed of 20 sensors and aims at covering the whole structure of the tank. For both tests, AE signals were recorded with 35dB acquisition threshold; gain of preamplifiers was 34dB; sensors were resonant at around 200 kHz.

Figure 6. Sensor layout on GFRP tank for the passive monitoring.

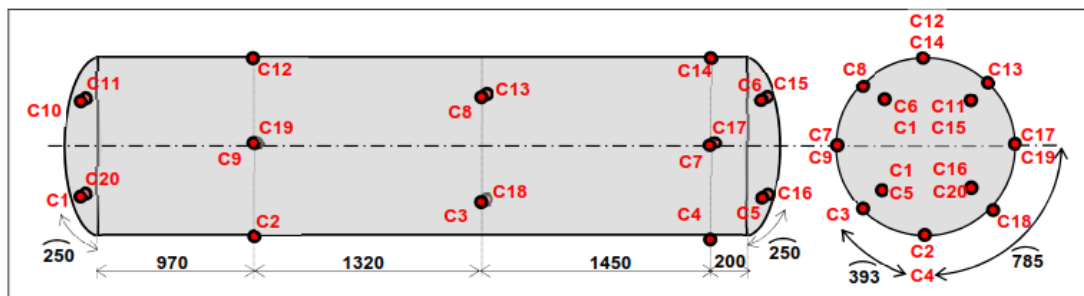
Figure 7. Sensor layout on GFRP tank for the AE proof test.

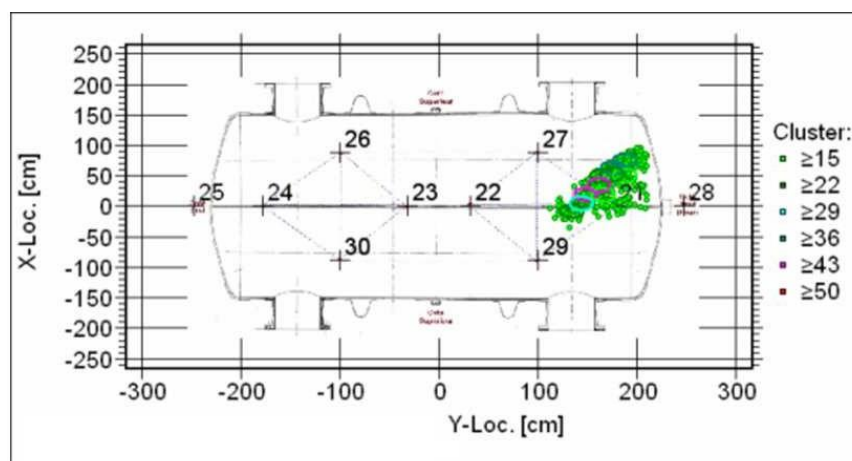
The analysis of the data from the 2 hour passive monitoring was based on classical methods like amplitude distribution, activity chronology and source localization. The figure 8 shows the planar localization of the AE events, using an algorithm based on the arrival-time differences. The events are localized in the developed plan of the tank structure. One can identify an area highly concentrated in AE events, close to the sensor C21 (more than 50 events in a 25cm x 25cm section). In addition, the chronologic trend of these events is consistent with a natural phenomenon (non-linear but continuous phenomenon). The analysis has led to the conclusion that the localized area close to the sensor C21 is probably related to corrosion of the tank structure.

Figure 8. Planar localization of AE events during the passive monitoring.

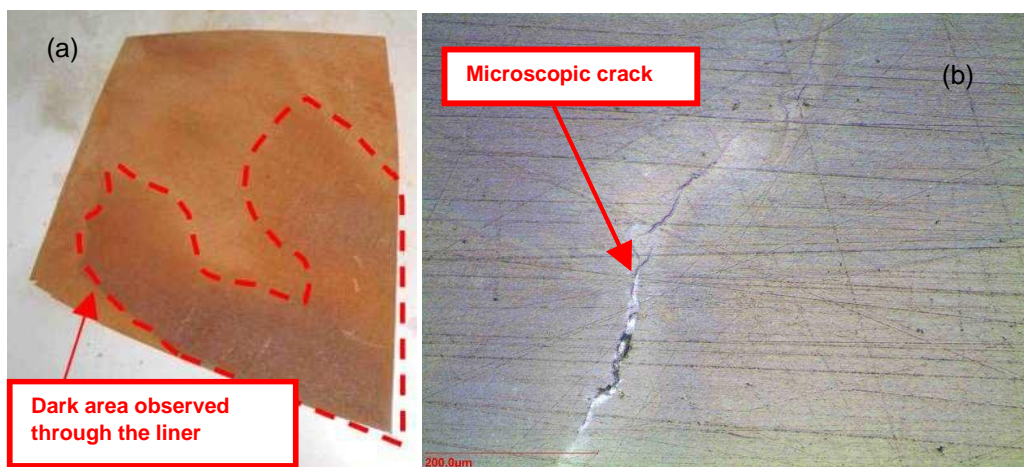
After AE measurements, the tank was removed from service, dissected and inspected. The inspection was focused on the emissive area detected and localised during the AE passive monitoring. The figures 9(a) and 9(b) illustrate the observations performed on the internal PVDF liner. The visual inspection, figure 9(a), shows that the internal surface of the liner is colored because of the bromine migration, but no macroscopic crack or blister is visible. Micrographic examination, figure 9(b) reveals some micro-cracks, close to the weld seams.

Figure 9. Inspection of the PVDF liner (a) visual (b) micrography.

The PVDF liner is fixed to a synthetic fiber fabric which provides the adhesion between the liner and the GFRP laminate. In the emissive area, the liner is easily detached from the laminate; some bromine spots are visible at the interface liner/laminate. In the non-emissive area, the liner is well attached to the laminate. No bromine spot is visible at the interface liner/laminate.

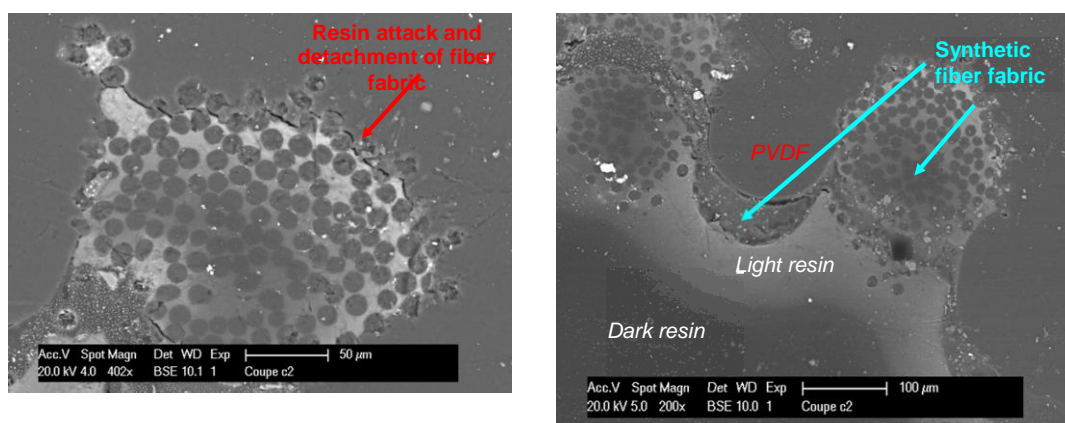
Scanning electron microscopy with energy dispersive X-ray spectroscopy (SEM/EDX) investigations were performed on the interface between the liner and the laminate (figure 10 and table 3). The analysis of these investigations shows a slight diffusion front (≈ 100µm) of bromine in the resin of the laminate. This attack of resin is related to the detachment of the PVDF from the laminate.

Figure 10. SEM pictures of the interfaceliner/laminate

Table 3. EDX results of the area from the figure10.

PVDF		Light resin		Dark resin	
	Mass composition (%)	Atomic composition (%)	Mass composition (%)	Atomic composition (%)	Mass composition (%)	Atomic composition (%)
C	26.9	39.6	50.6	76.8	71.7	87.6
F	62.5	58.1				
O			13.1	17.9	27.9	20.4
Br	10.5	2.3	36.3	8.3	1.4	0.2

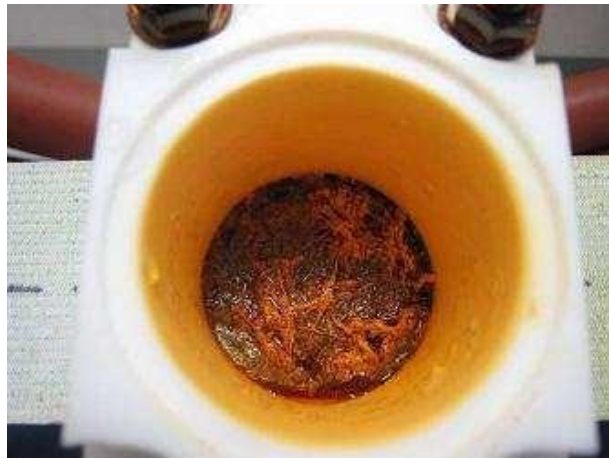
Corrosion tests were performed on GFRP specimen in contact with bromine, monitored with 2 AE sensors. The dimensions of the specimen are 50 x 300 mm, cut from a healthy area of the dissected tank. The PVDF layer is removed from the specimen. No surface treatment is done (the synthetic fiber fabric is still present). Figure 11 shows the specimen after the corrosion test.

Figure 11. GFRP specimen after corrosion test with bromine.

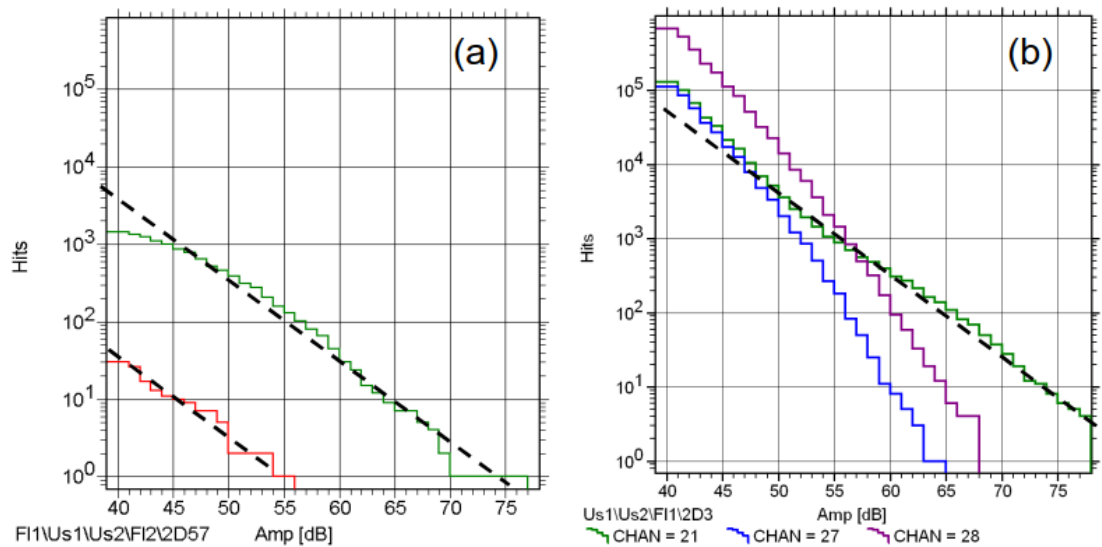
AE data from this test were compared with the AE data from the passive monitoring on tank. Cumulative amplitude distributions are shown in the figure 12 (Pollock plots). The slopes of these curves are similar for the laboratory test and for the field test. According to Pollock theory, this similarity confirms that the same failure mechanism is detected for both laboratory and field measurements. Other AE parameters were compared to corroborate this similarity.

Figure 12. Cumulative amplitude distributions (a) for the test on specimen (b) for the test on tank.
